TECHNICAL INSPECTION REPORT

6 OPERATION CROSSROADS.
U.S.S. CRITTENDEN (APA 77)

TEST ABLE.

VOLUME 2 [U].

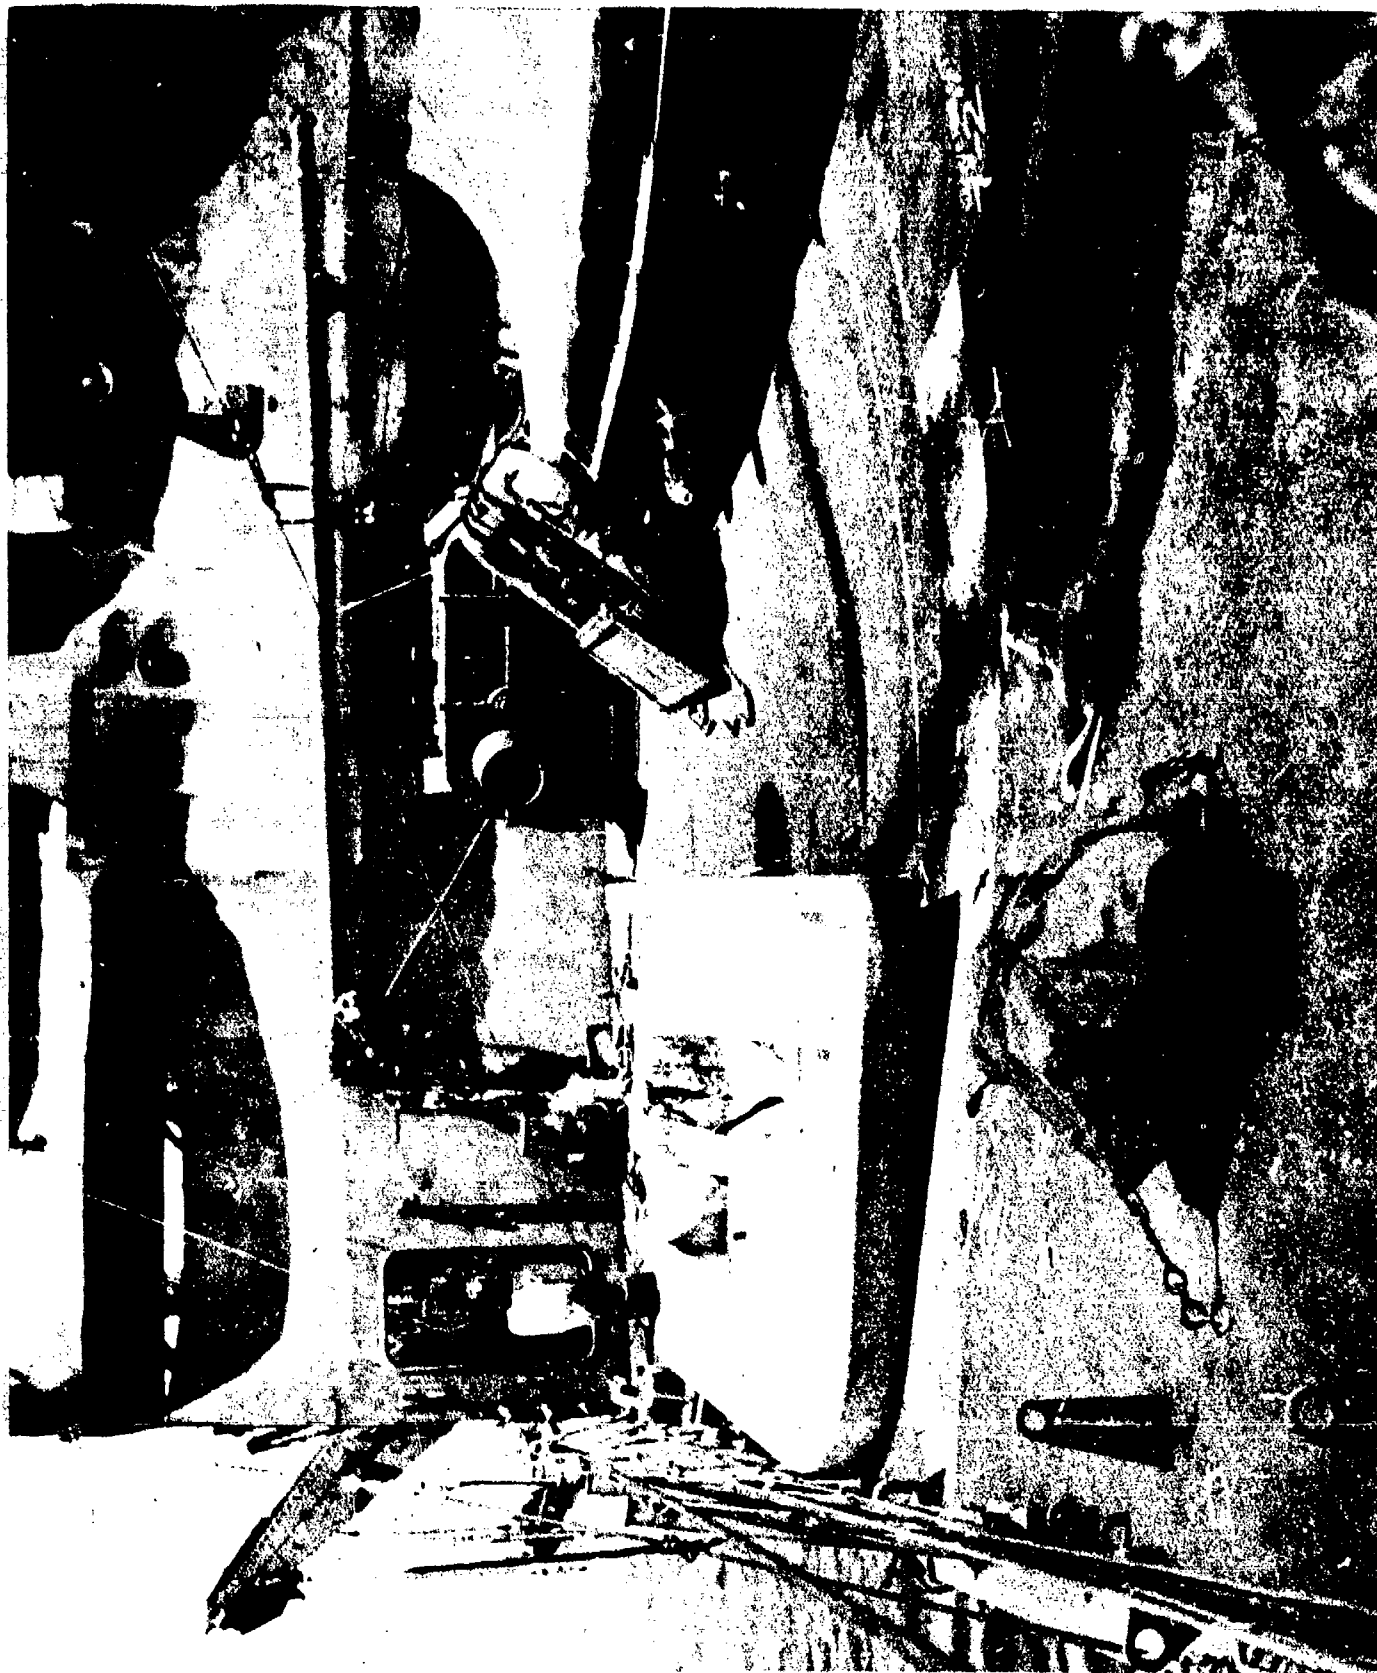
AA-CR-59-2086-10. Looking aft on upper deck, starboard, showing deck dishing in way of forward cargo hatch. (Note buckled pontoon-type hatch cover.)

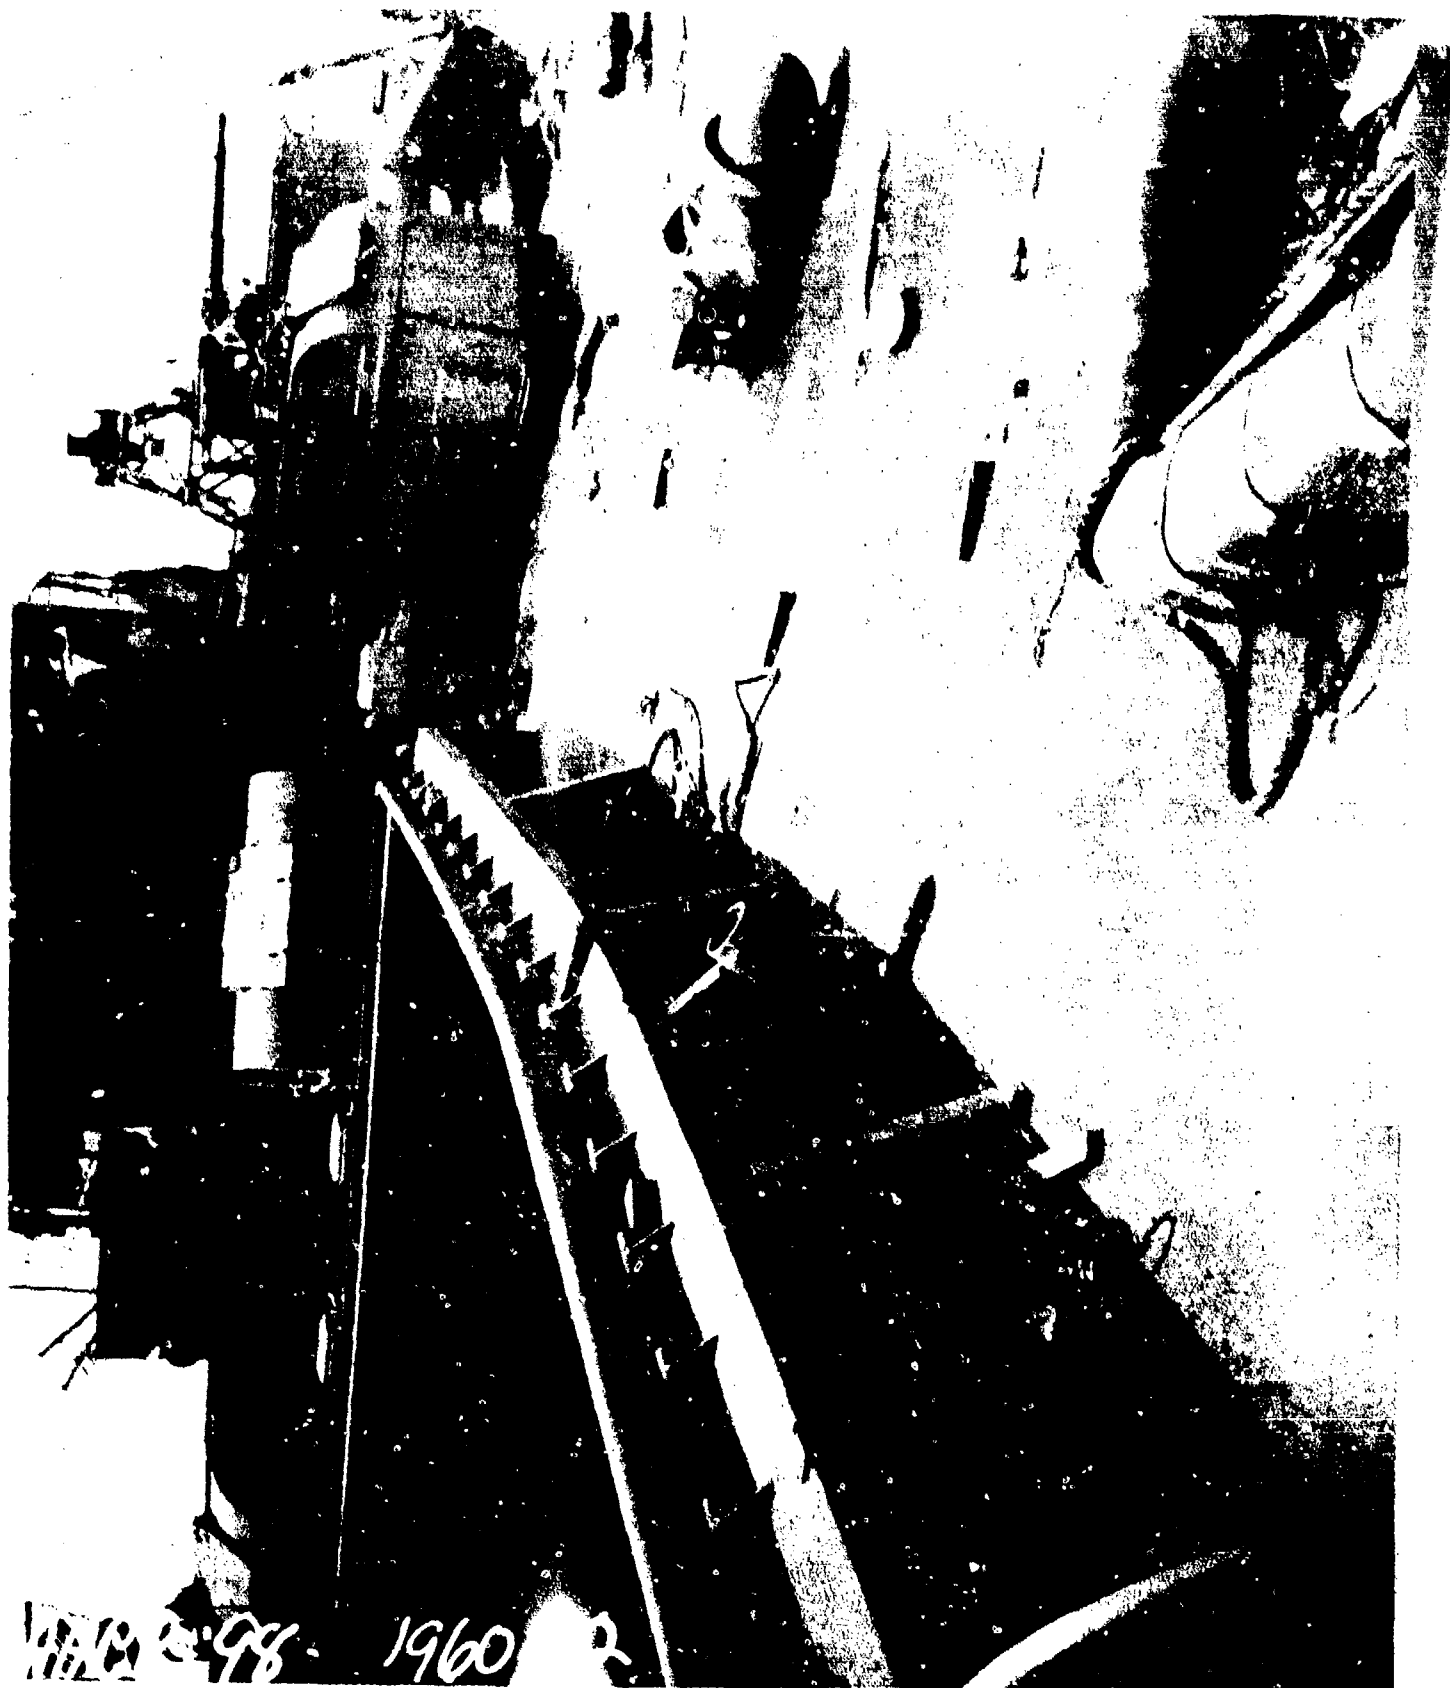
AA-CR-98-1960-2. Looking forward on upper deck, starboard side, showing deflected hatch coaming and deck dishing in way of forward cargo hatch.

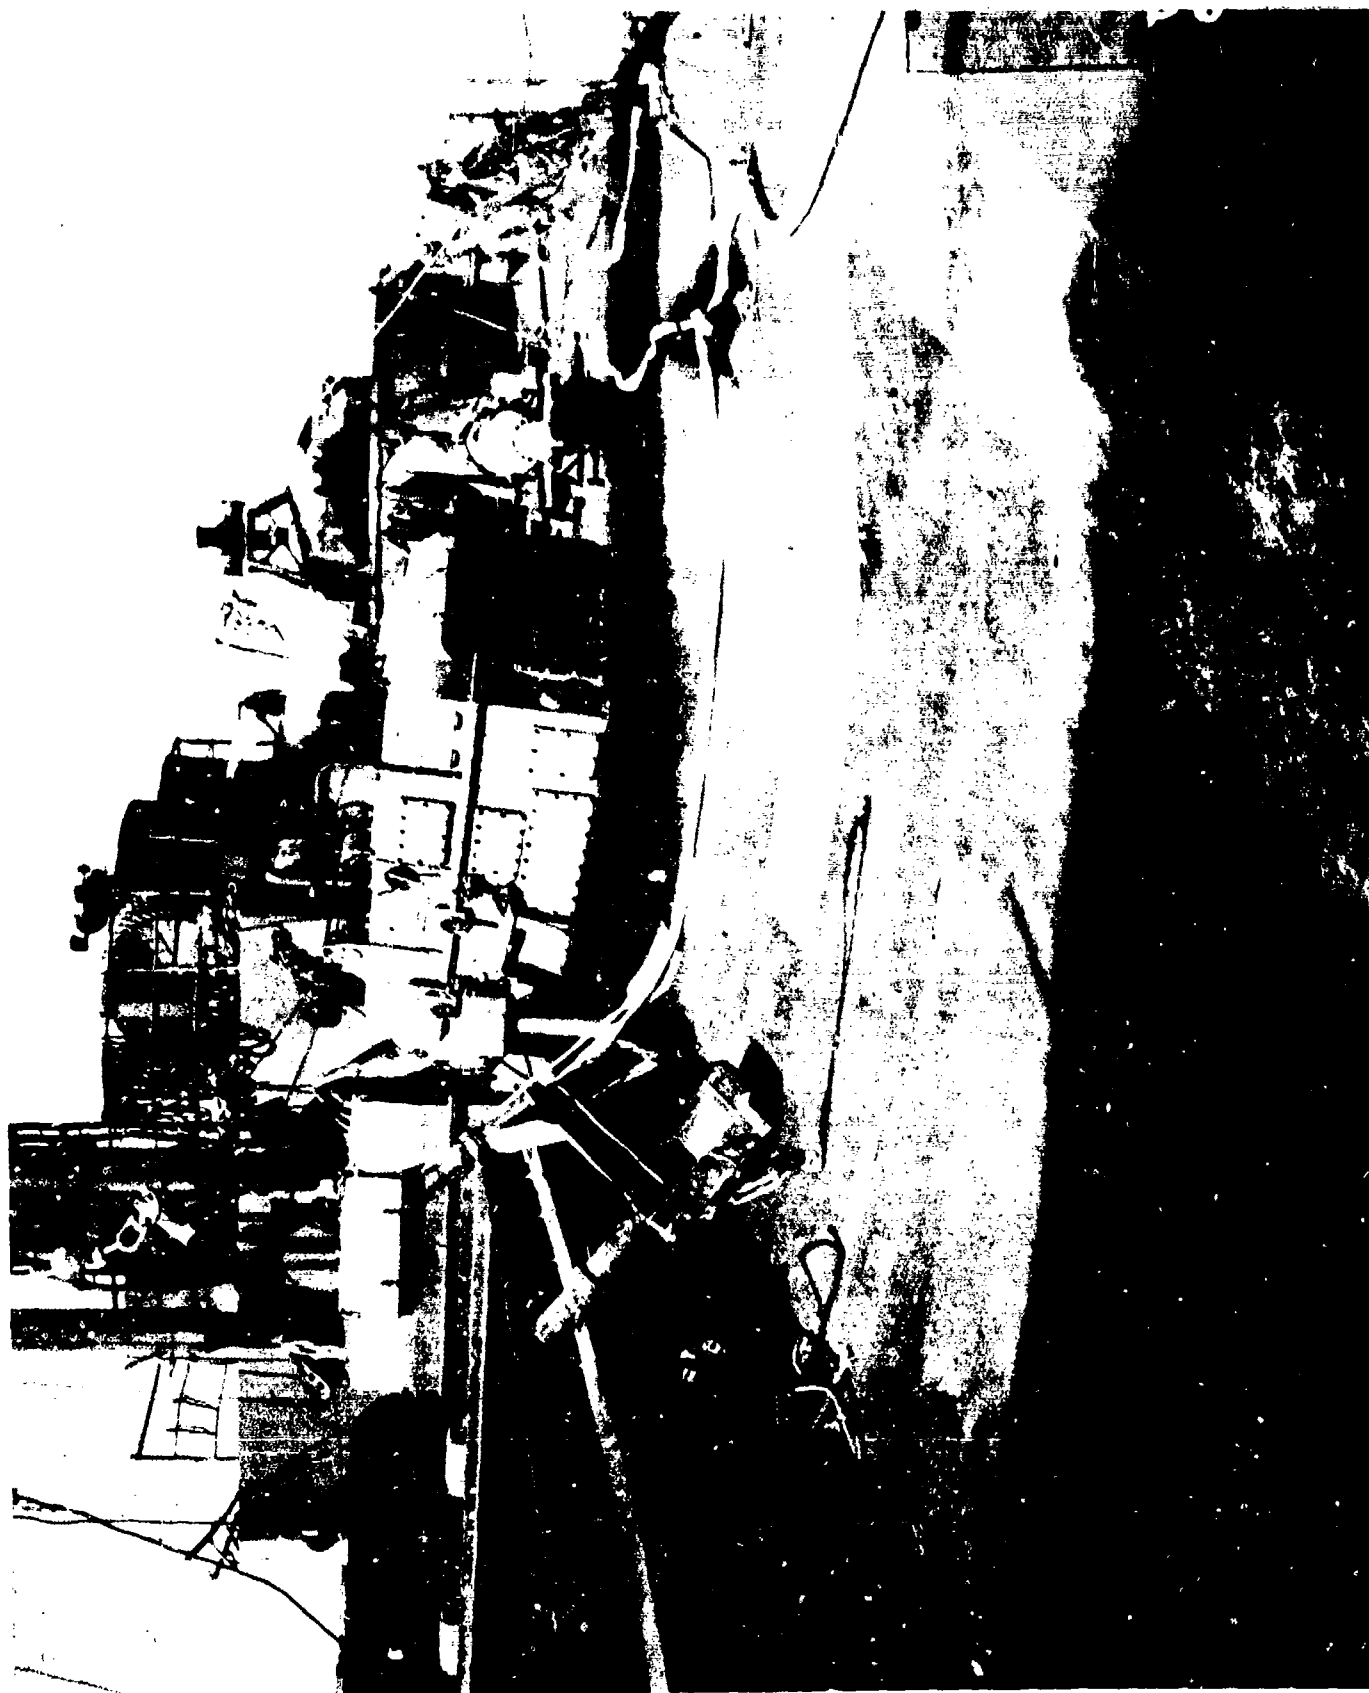
AA-CR-88-2101-12. Looking forward on upper deck, starboard, showing deck dishing in way of forward cargo hatch.

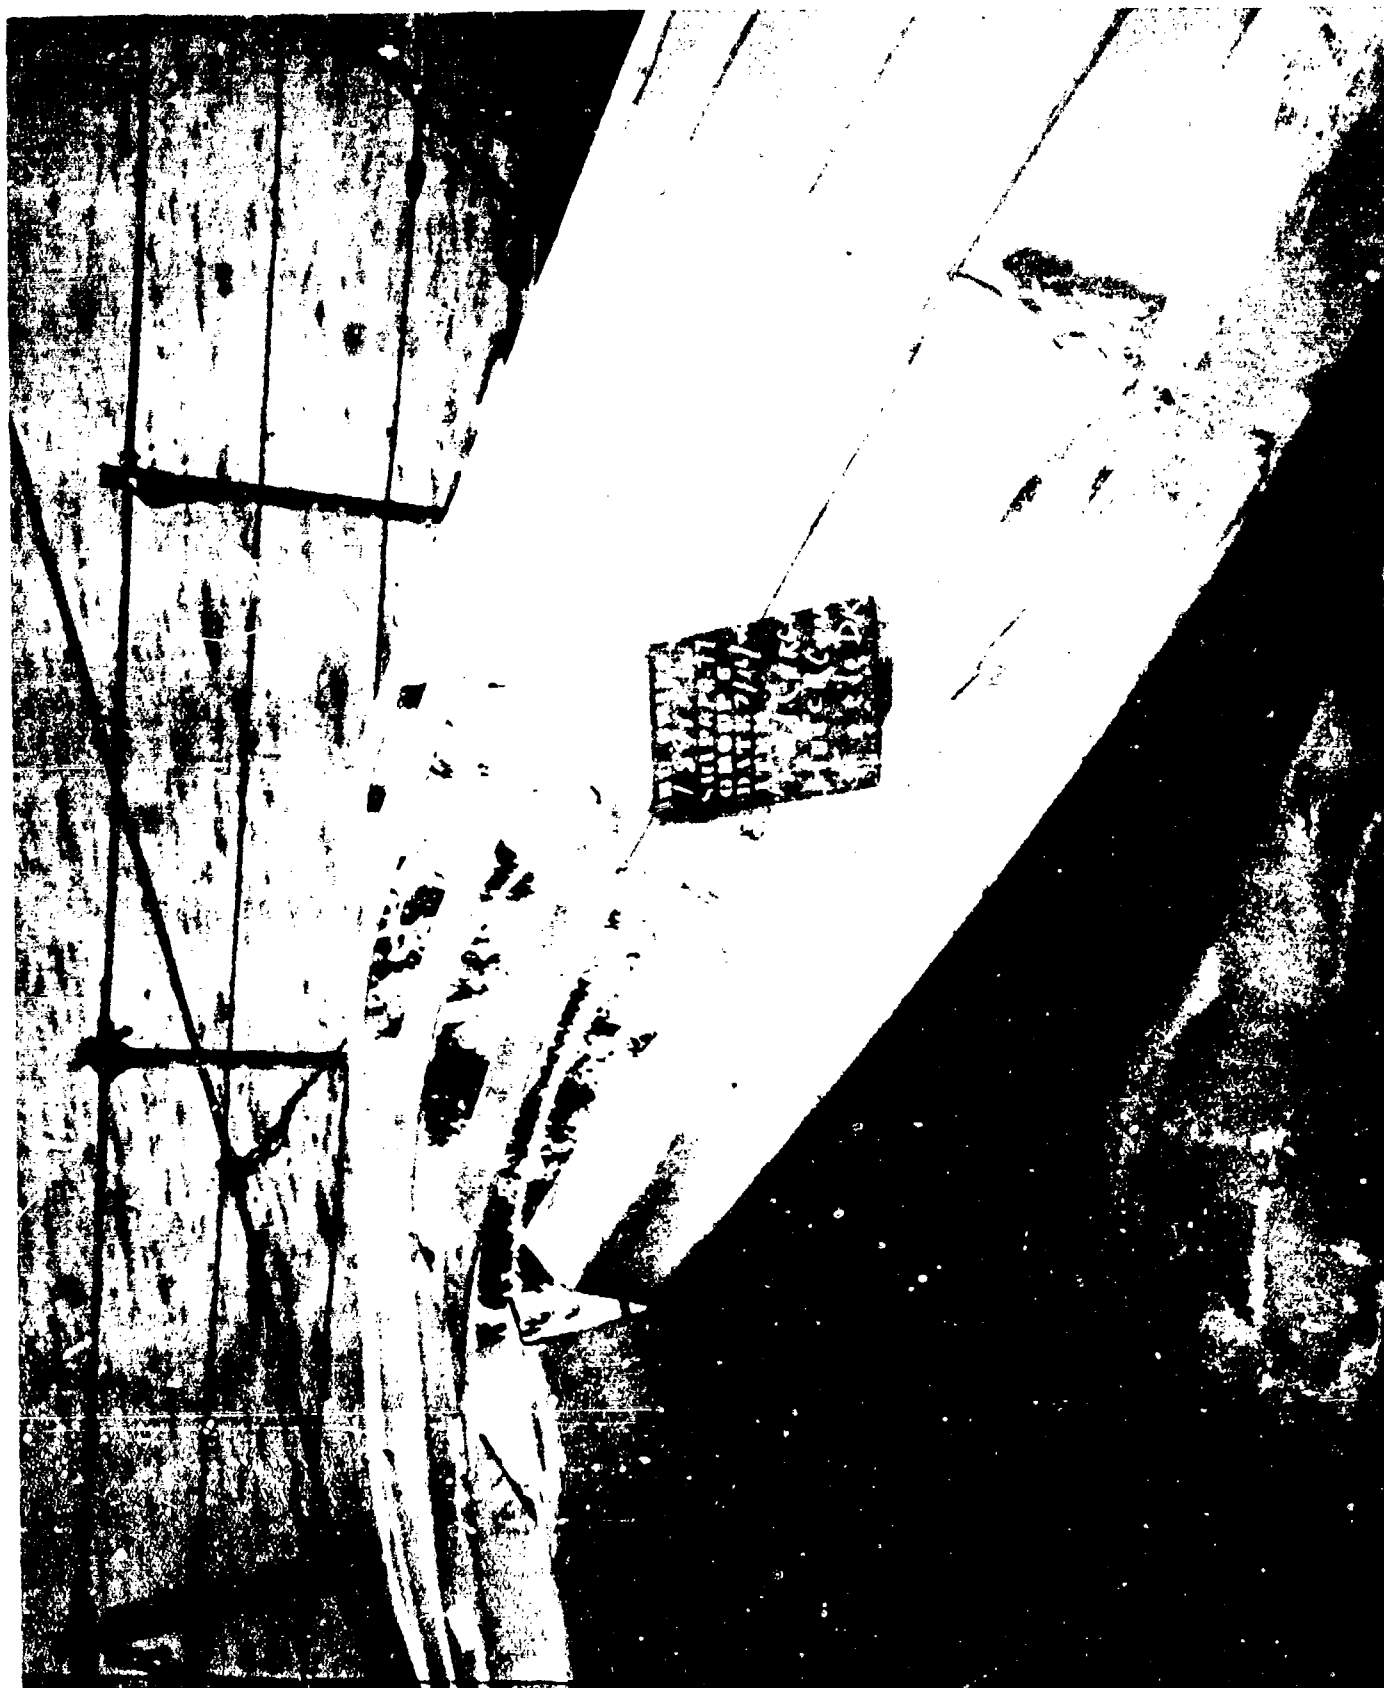
AA-CR-100-1891-6. View of damaged pontoon type cover from forward cargo hatch showing stress lines. For general views see 2086-10 and 2058-6; for close-up views of stress lines see 1891-5, 7, 8, 9.

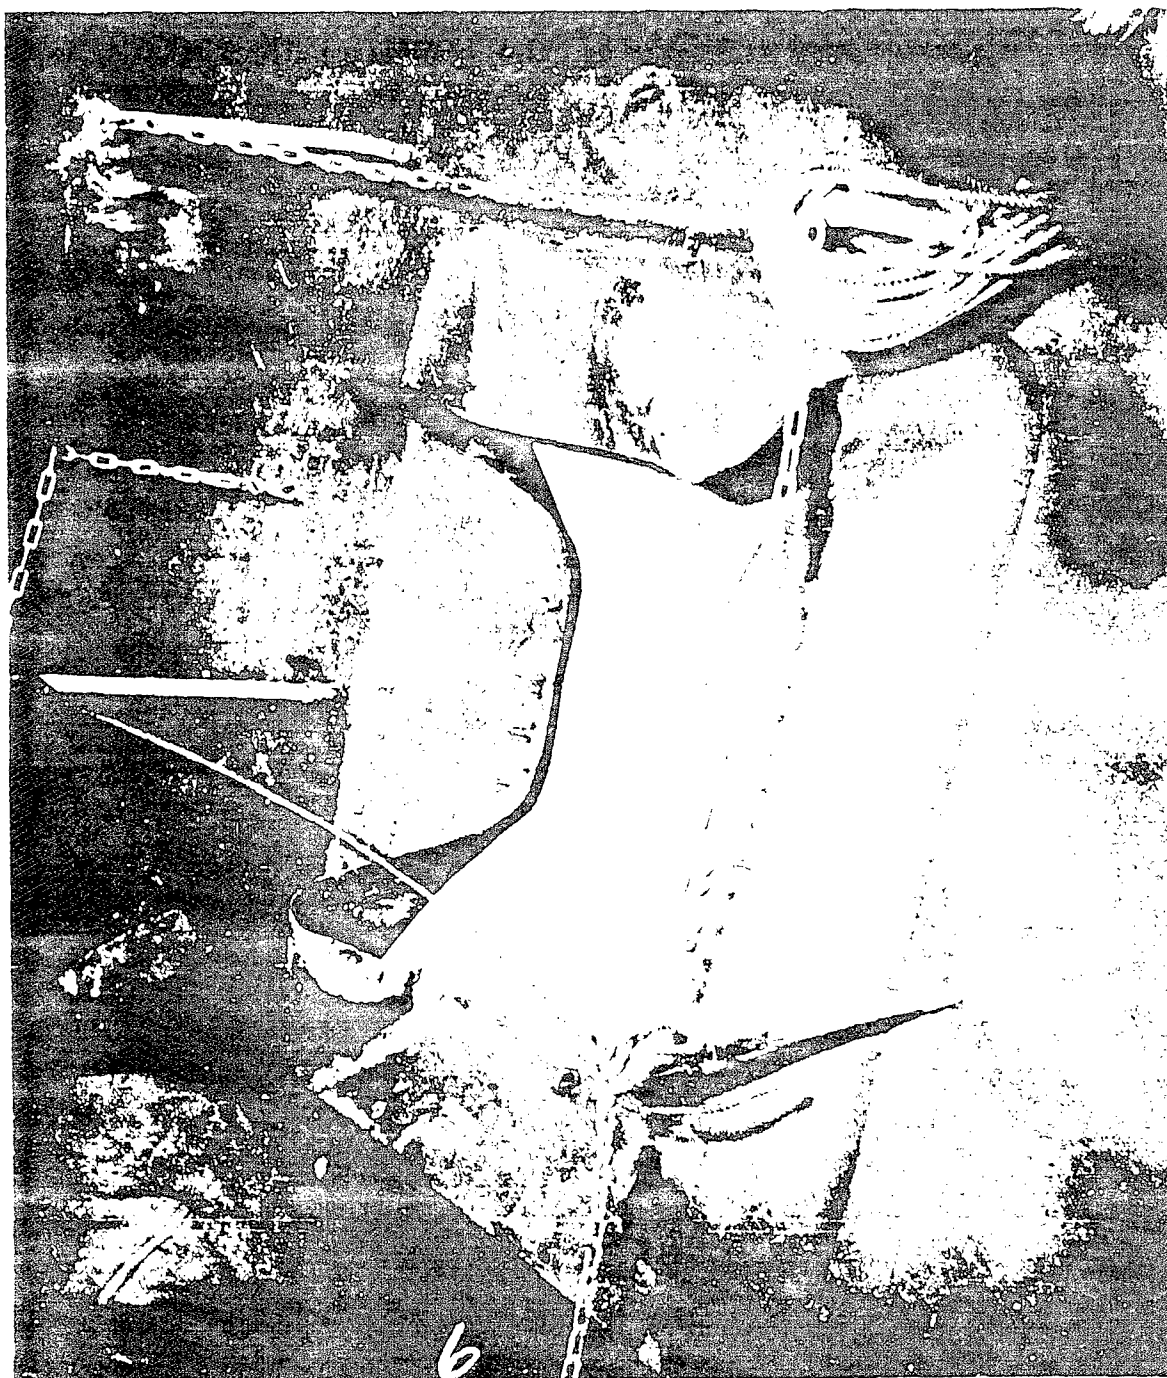
AA-CR-80-1901-6. Looking to port and aft on upper deck showing damaged coaming of ammunition trunk hatch.

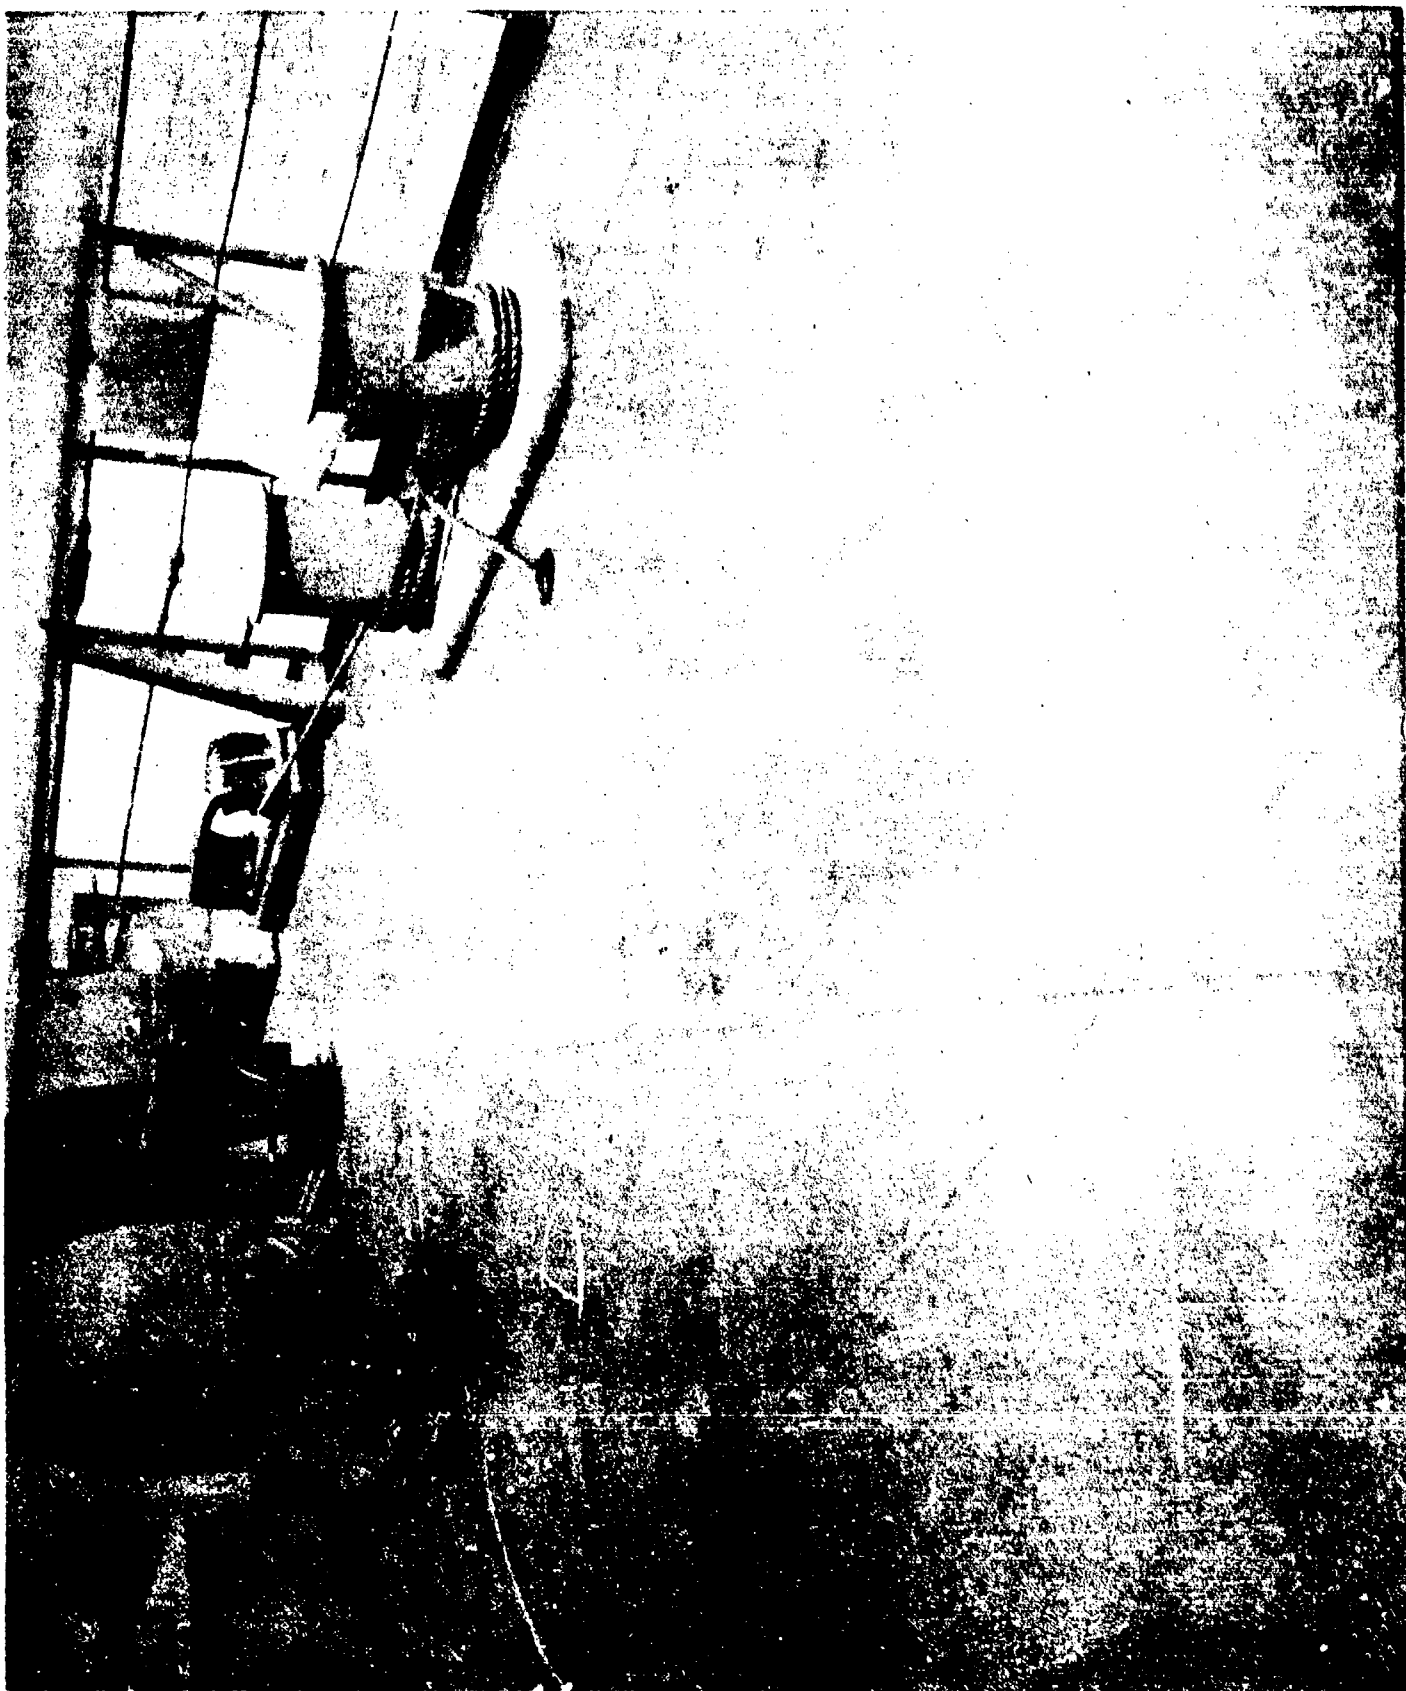
AA-CR-80-1908-11. Looking forward and to starboard on upper deck aft showing deck dishing inboard of the starboard bitts at frame 156.

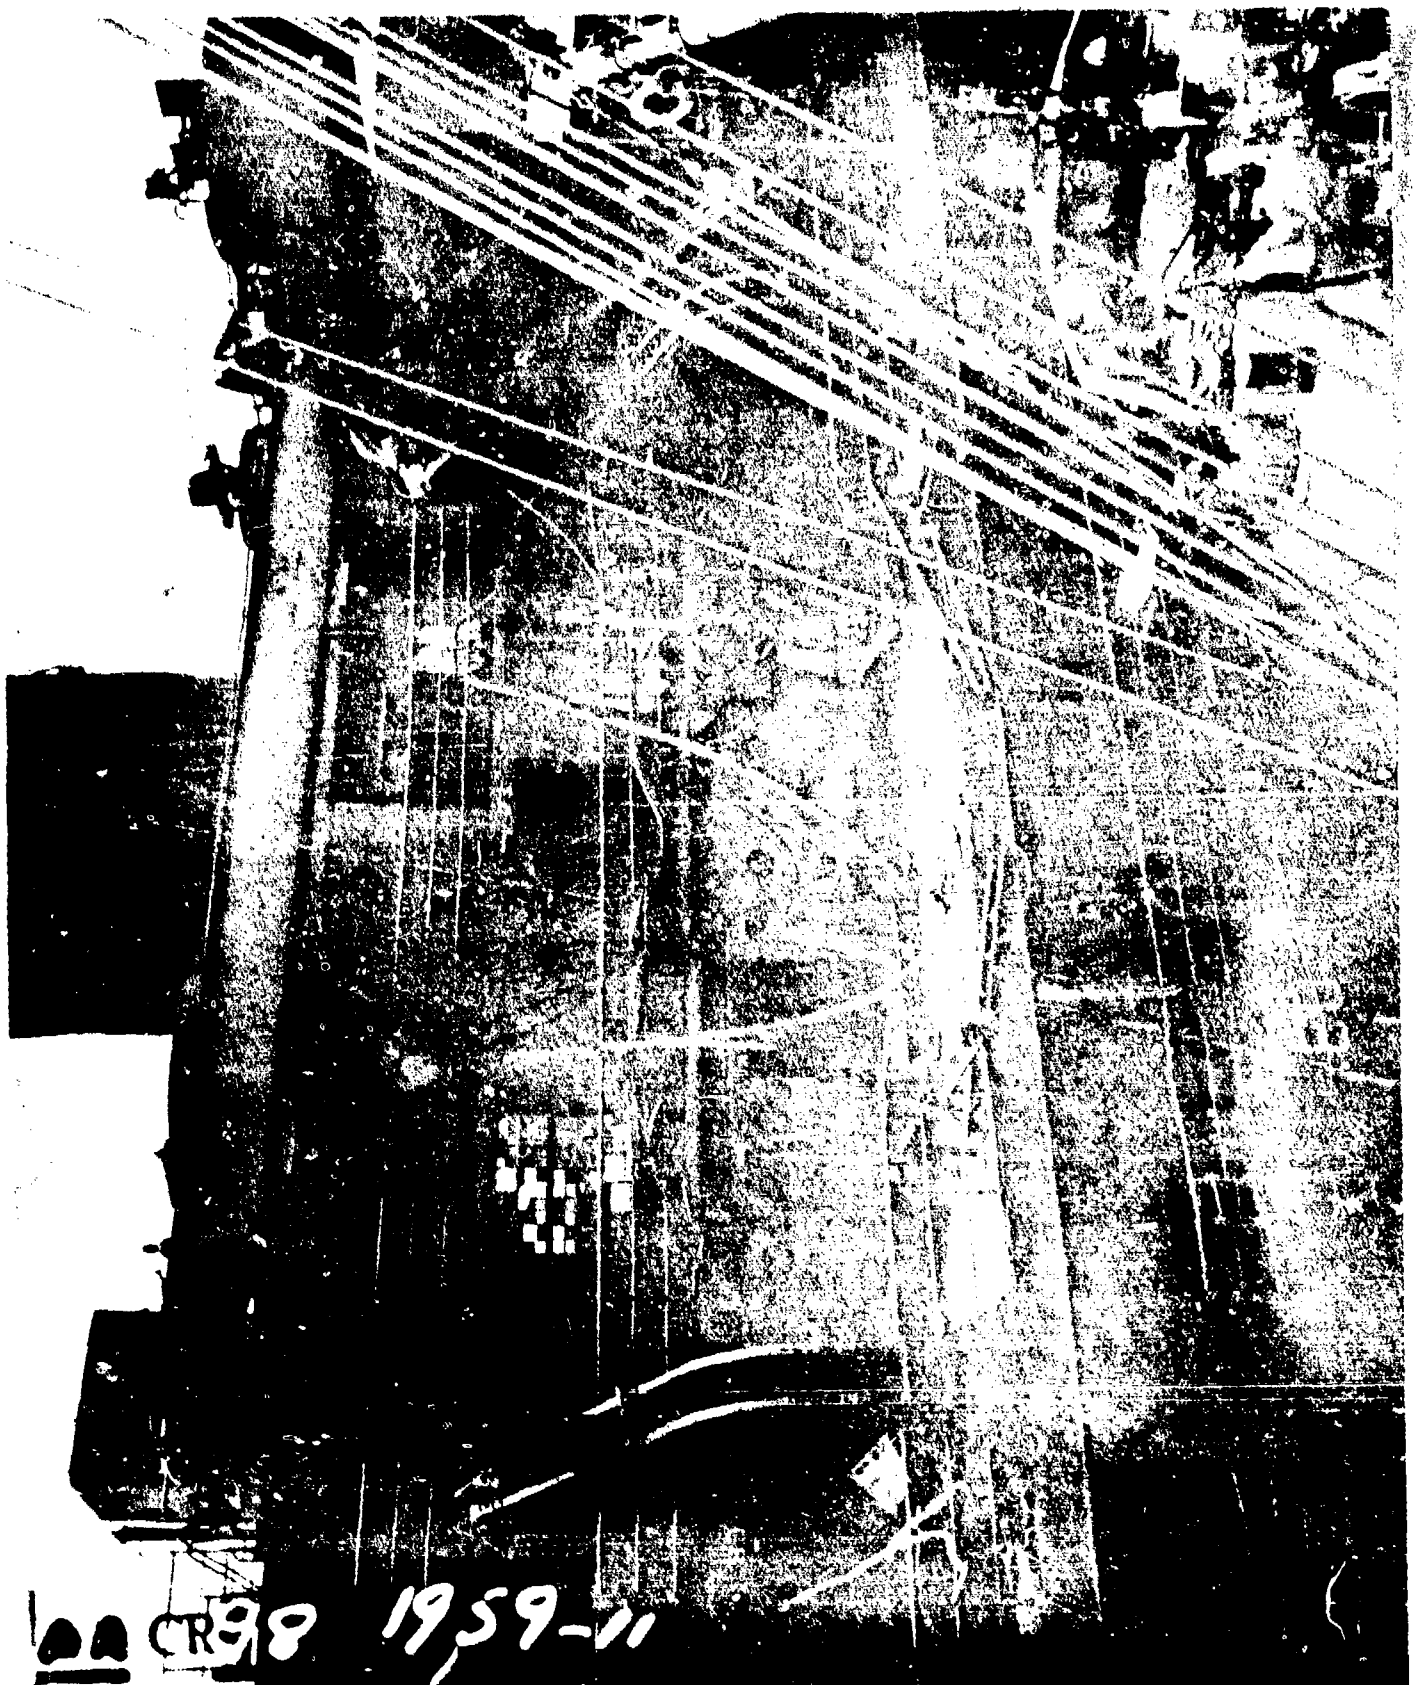
AA-CR-98-1959-11. Starboard side view of superstructure, frames
60 to 88.

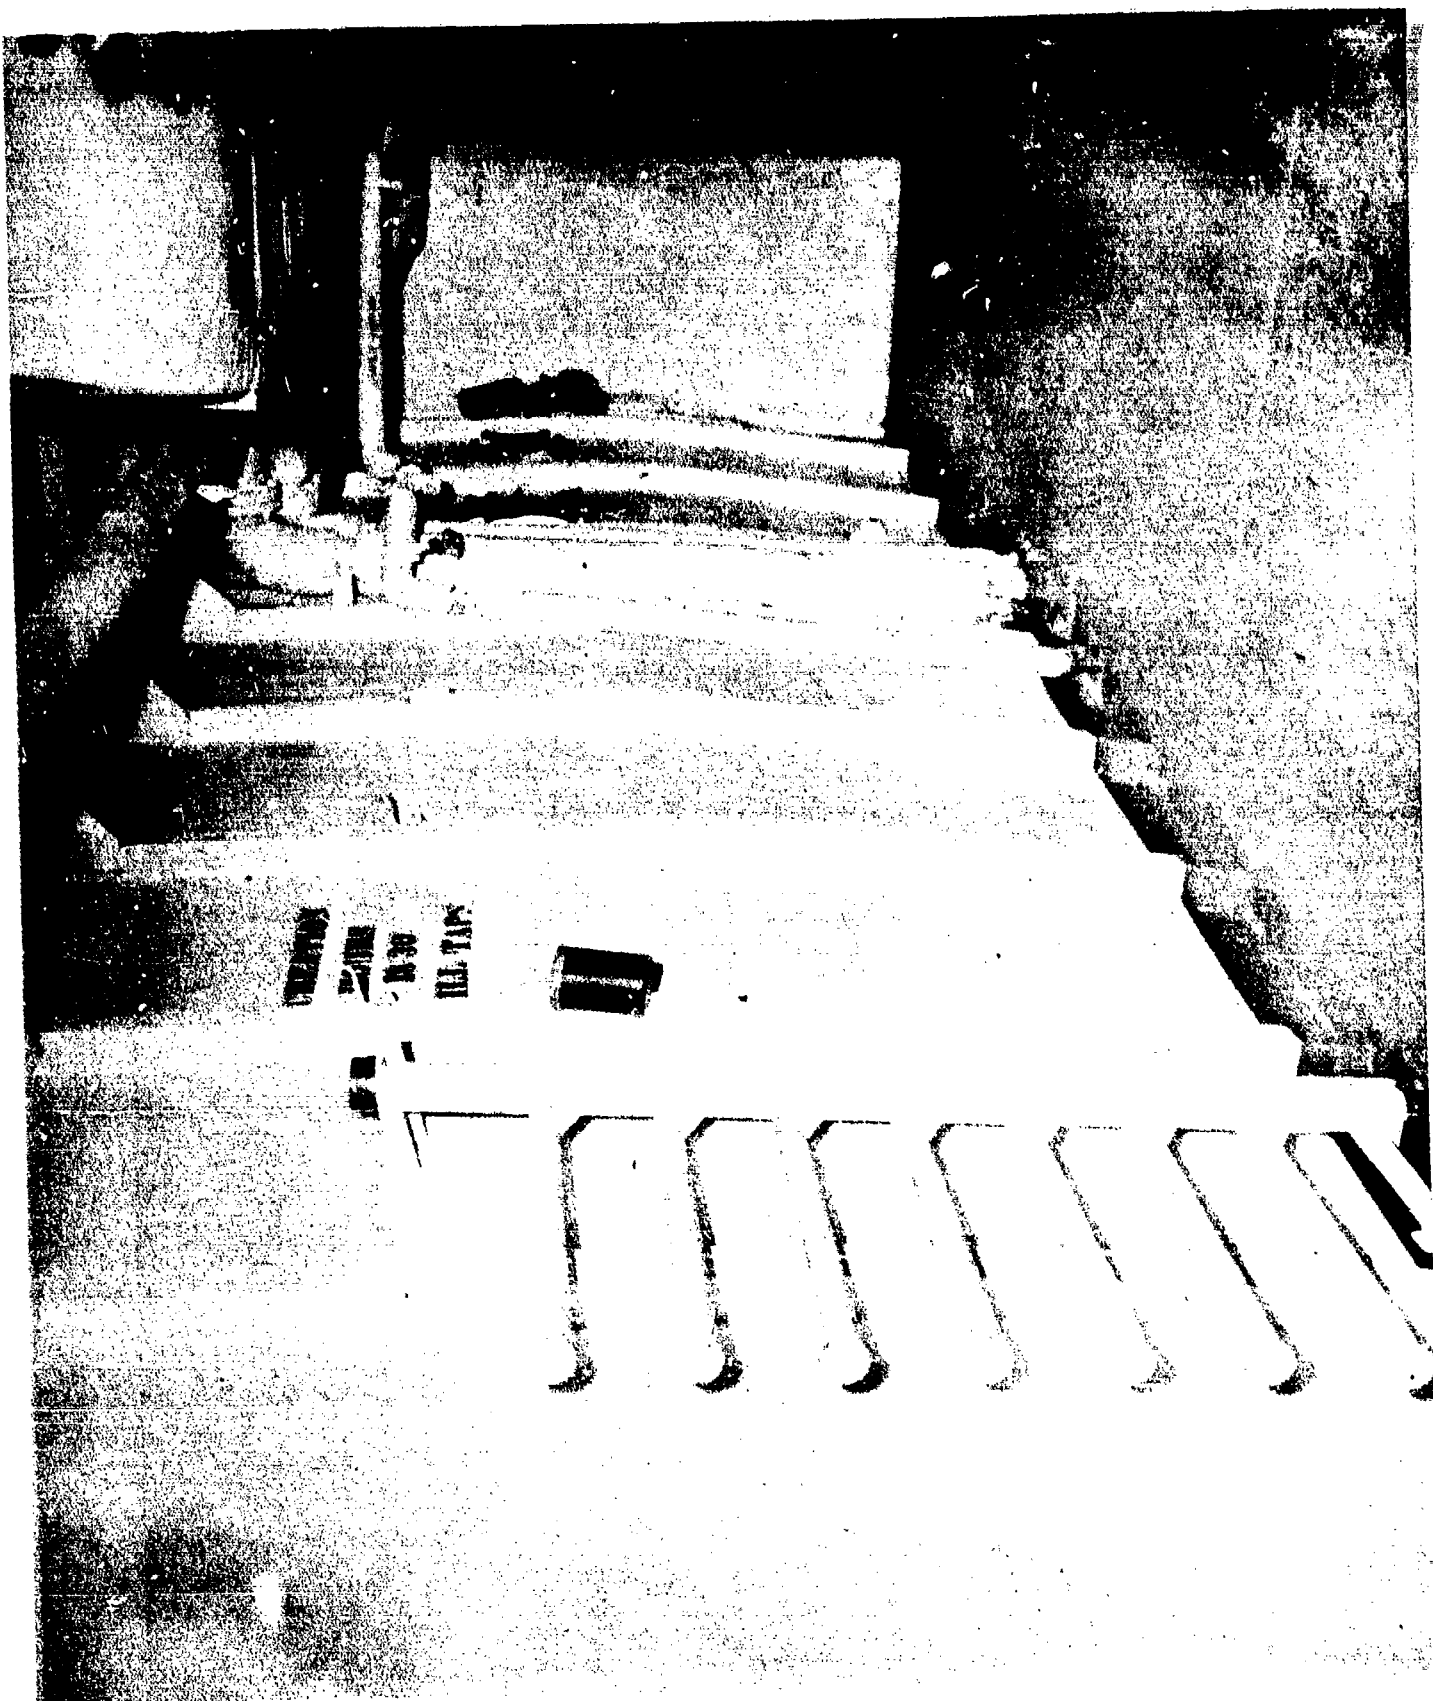
AA-CR-80-1908-10. Looking aft and to starboard on main deck in troop mess compartment B-102L showing dishing of starboard well deck longitudinal bulkhead, frames 70 to 80.

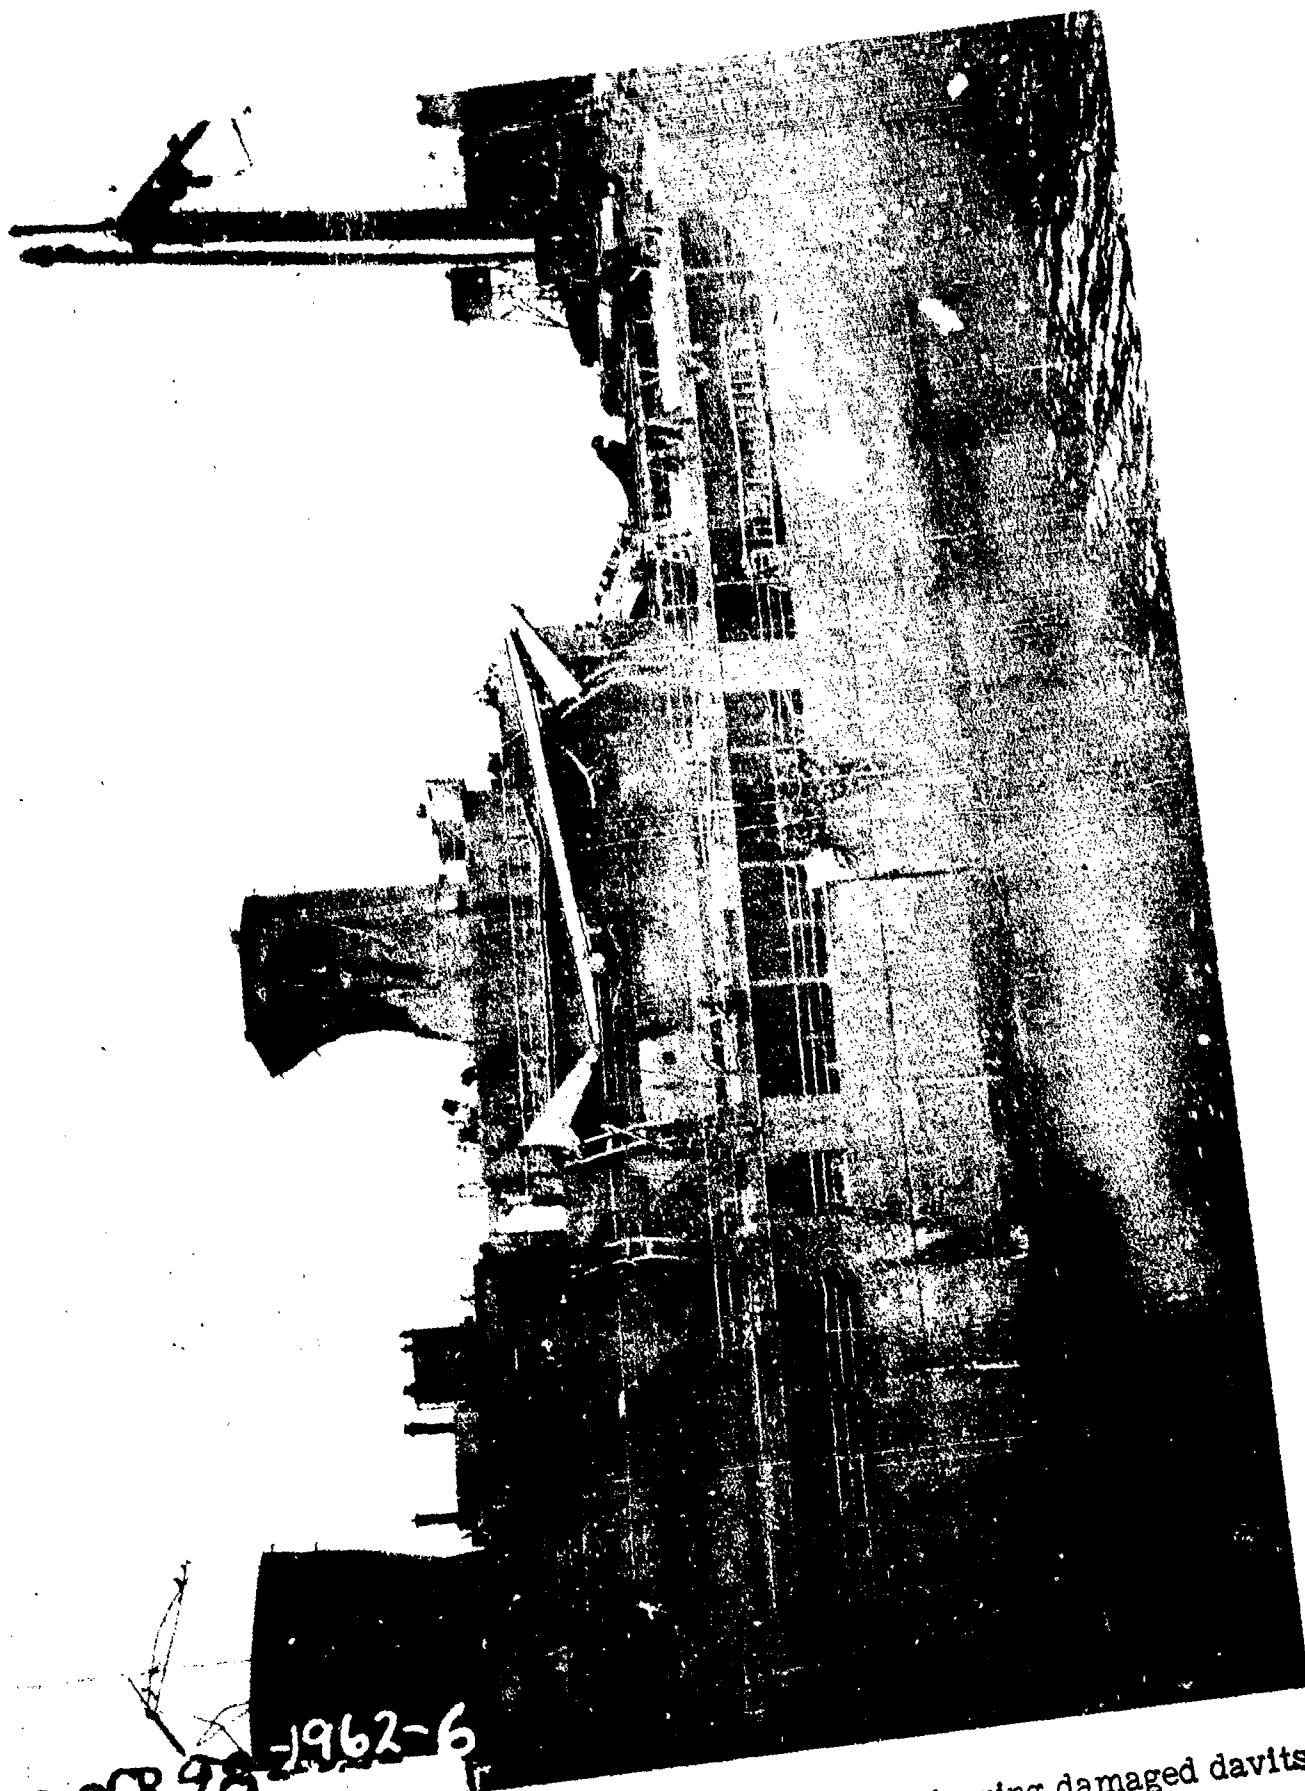
9/ACR 98-1962-6

AA-CR-98-1962-6. View from off port beam showing damaged davits.

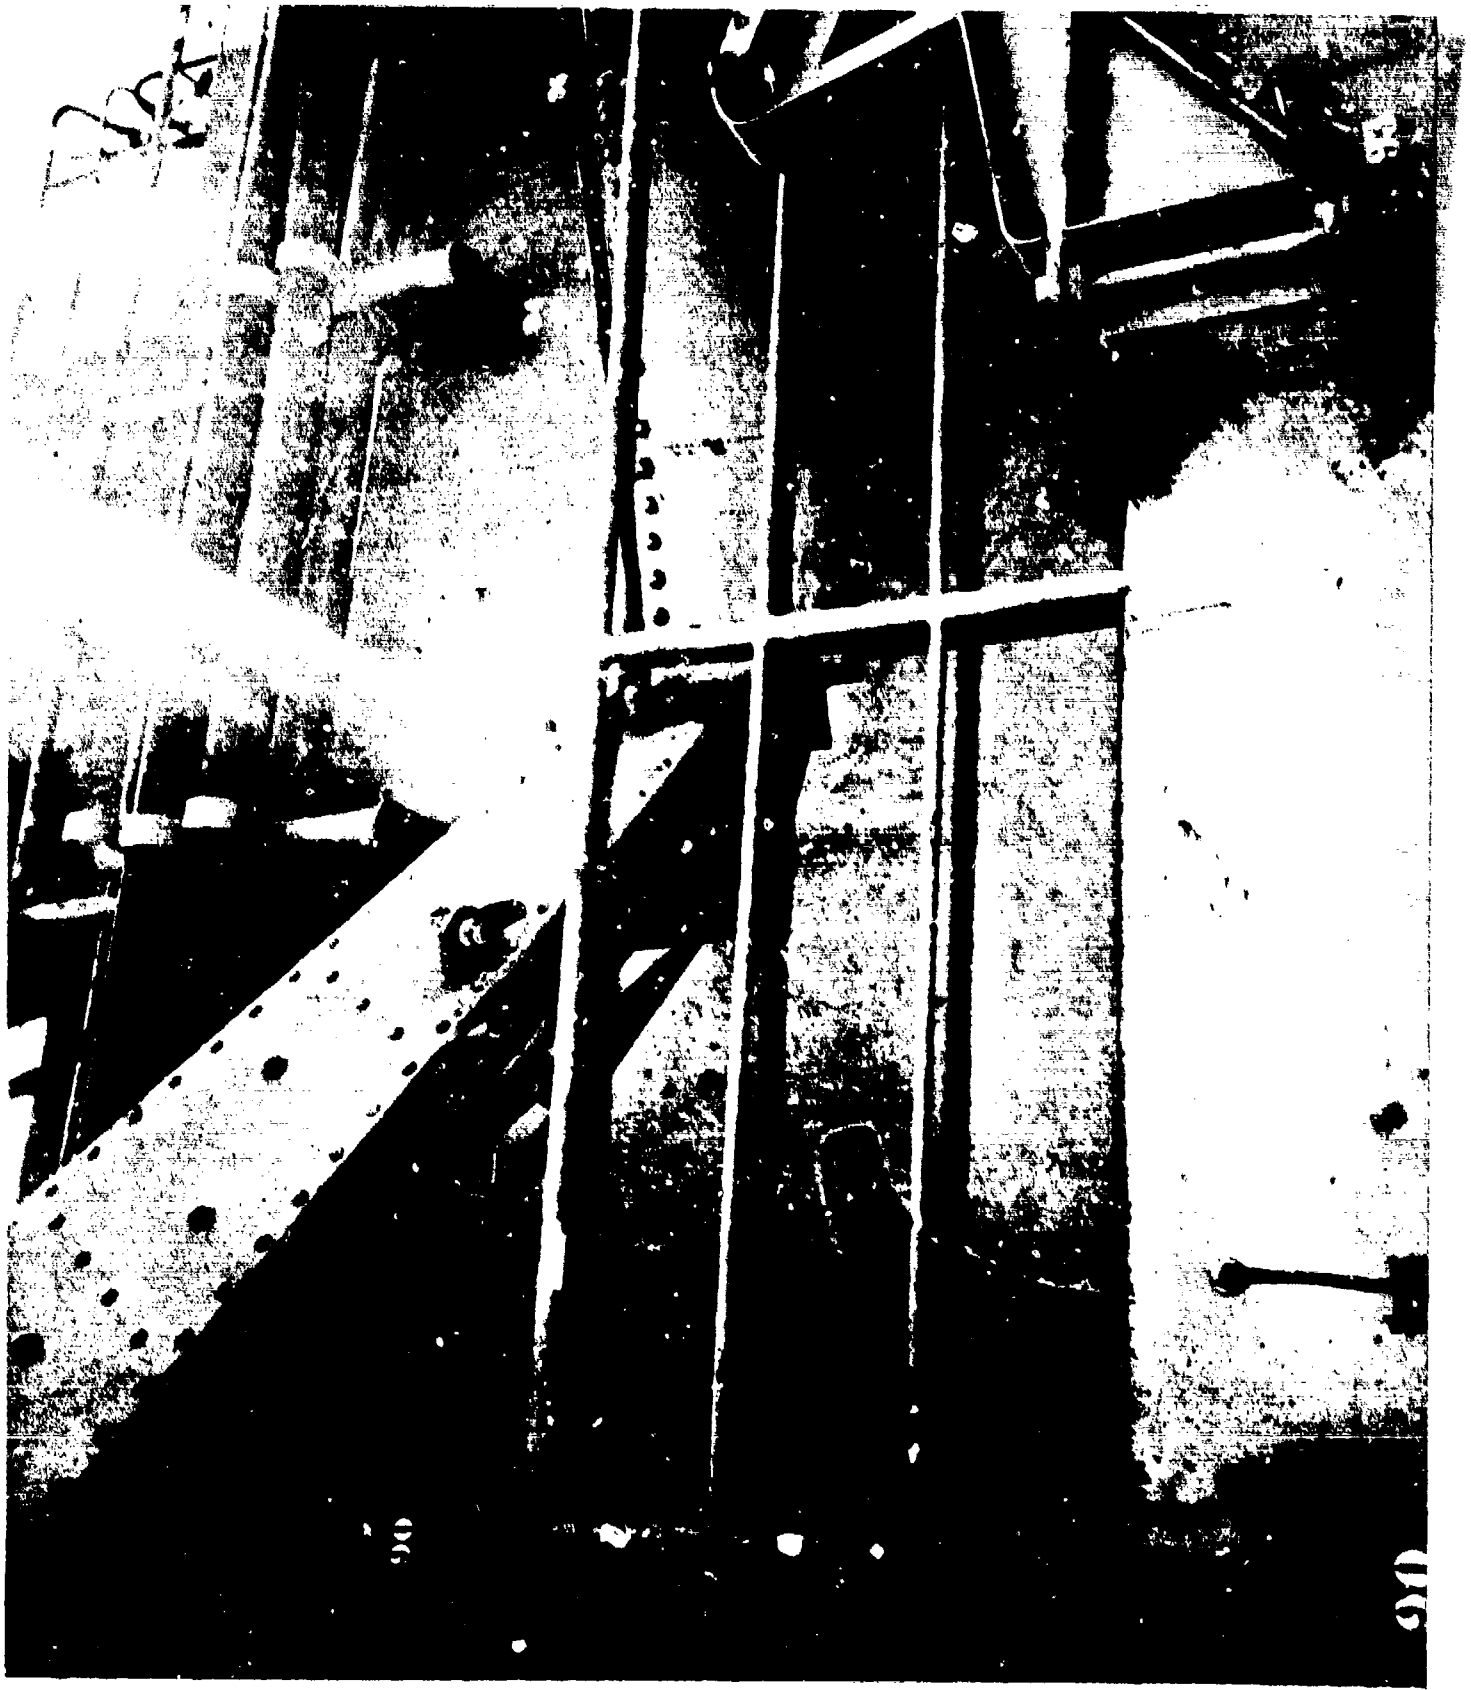
AA-CR-82-1922-7. Close-up dislocated port davit at frame 89.
